# Tributary of Reesor Creek Erosion Hazard Assessment

## 12811 Tenth Line

Whitchurch-Stouffville, ON

GEO Morphix Project No. 25157

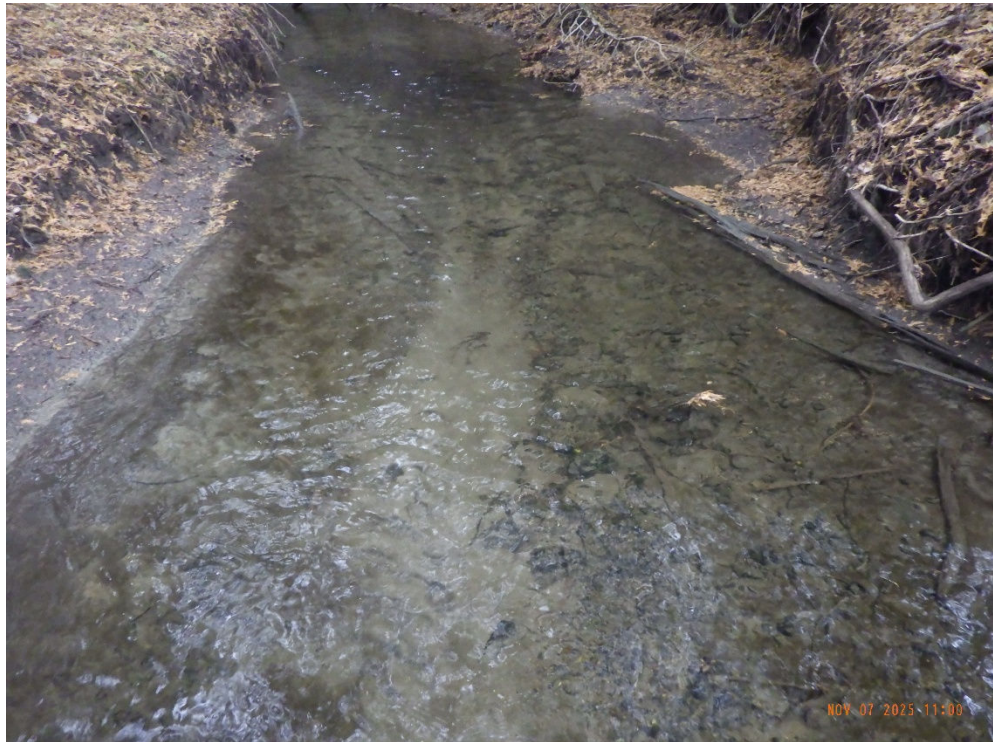
**Photo 1**  
Reesor Creek Tributary, Whitchurch-Stouffville  
**Reach RCT2**

Photograph taken facing upstream showing a riffle mostly composed of gravel, sand, and clay/silt.

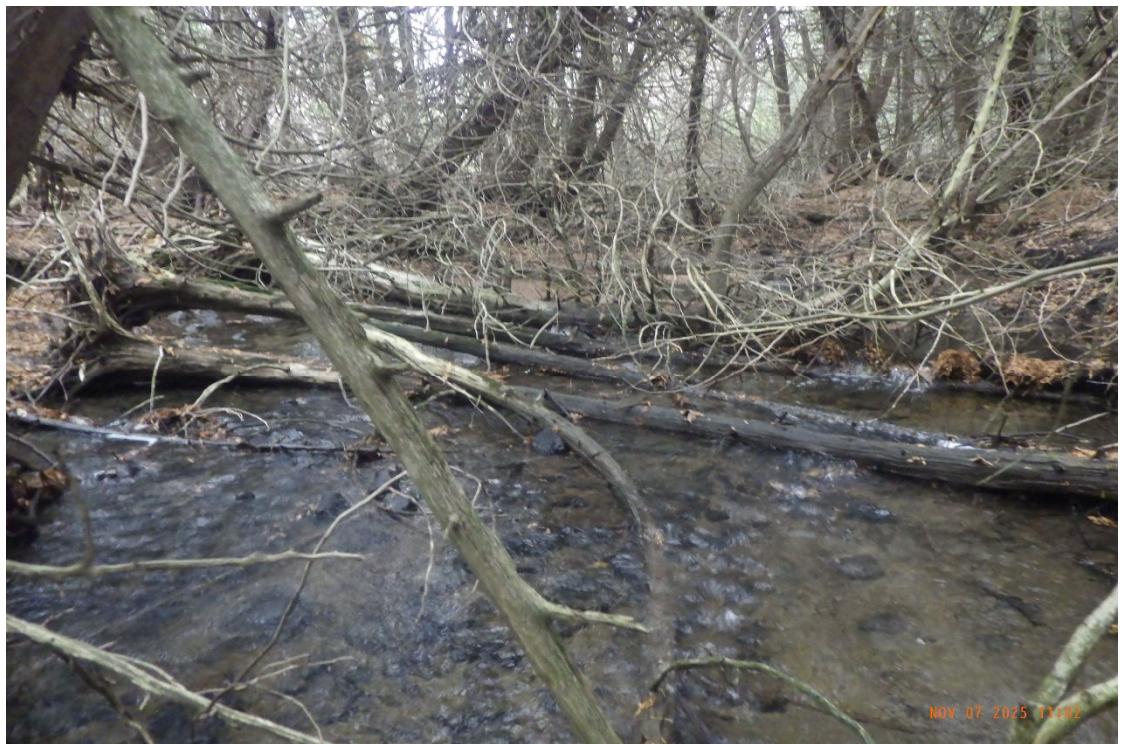
**Photo 2**  
Reesor Creek Tributary, Whitchurch-Stouffville  
**Reach RCT2**

Photograph of fallen trees that caused a woody debris jam (which was a common occurrence throughout **Reach RCT2**) over a cobble-dominated riffle.

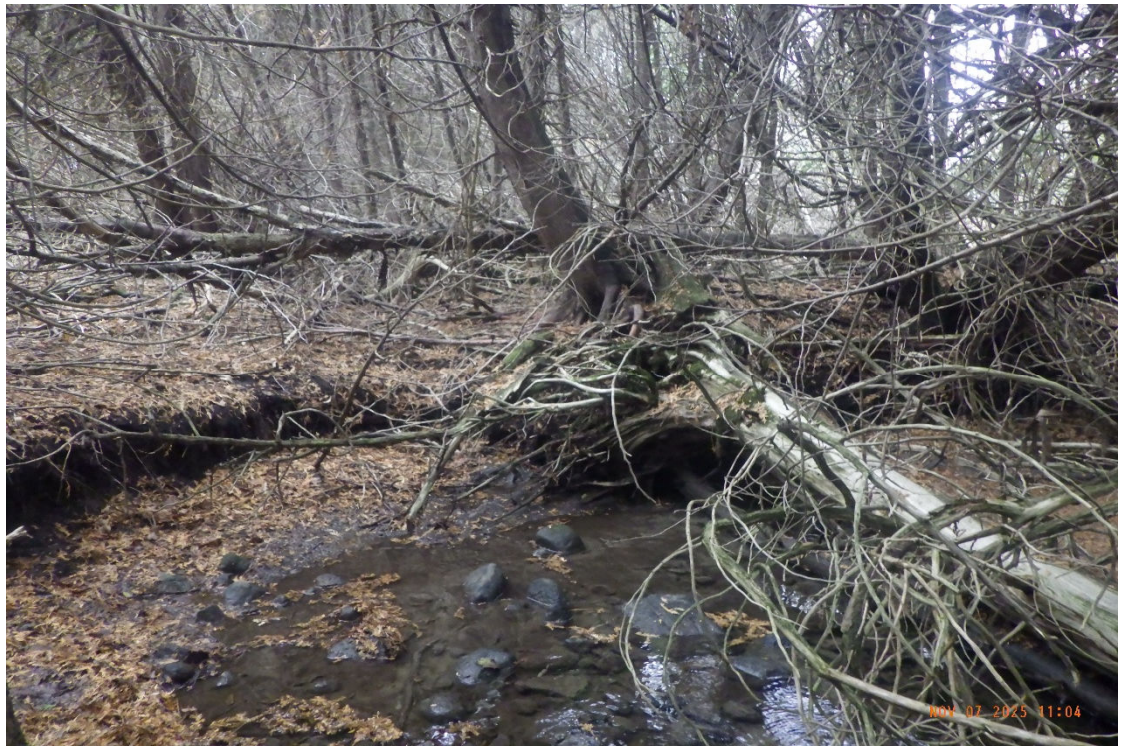
Photo 3

Undercuts (ranging from 0.16 to 0.32 m deep) were present throughout **Reach RCT2**. Basal scour was present in 60-100% of the reach. Exposed roots were common.

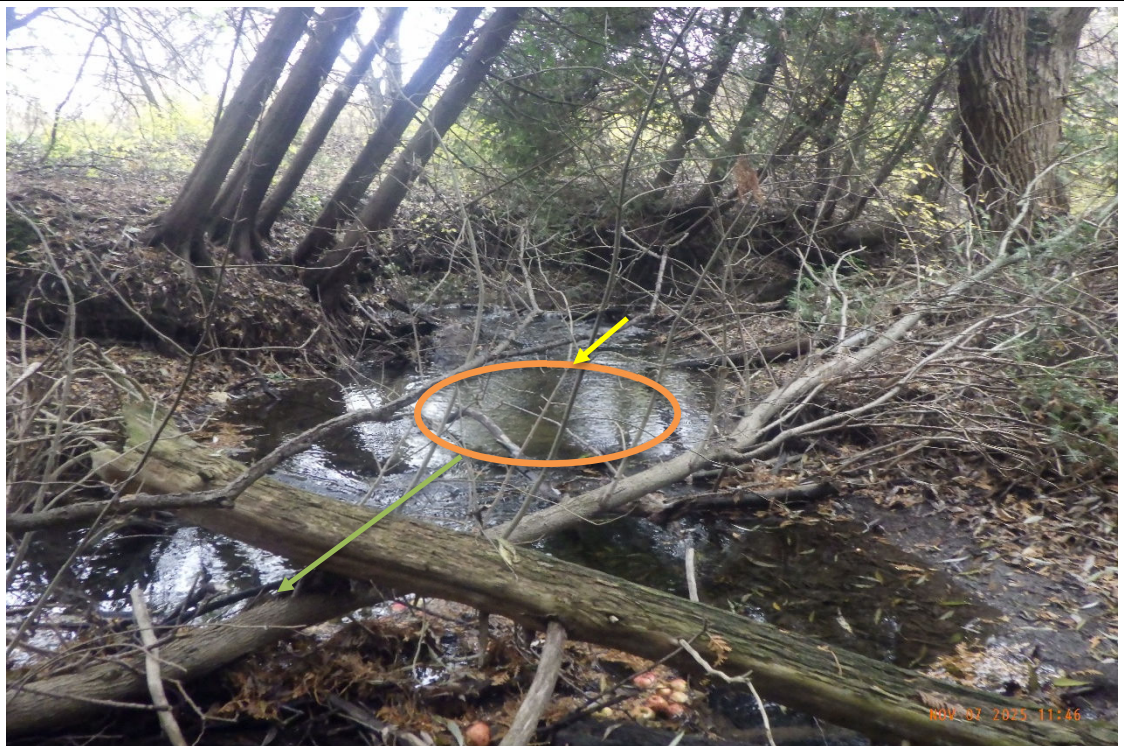
Photo 4

One riffle-pool sequence occurred along the reach that was 6.9 m in length, though riffles and pools were both relatively common. Yellow arrow indicates a riffle, orange circle indicates a pool. Note the leaning trees, which were a common occurrence along the reach.

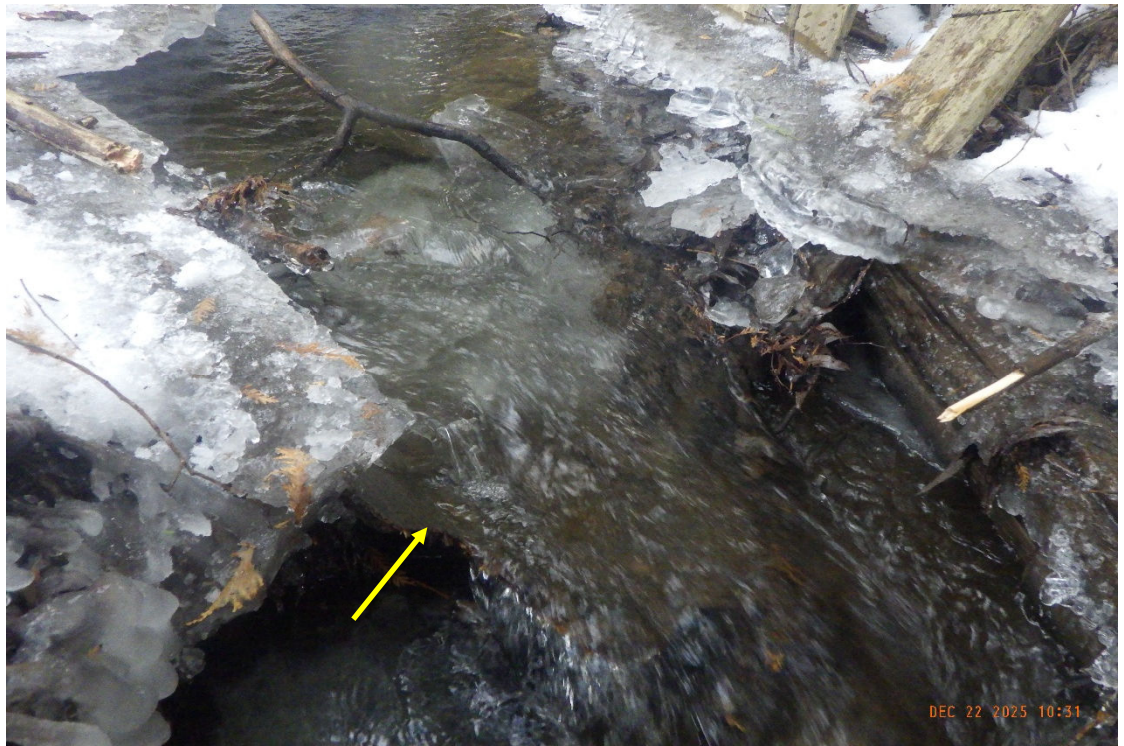
**Photo 5**  
Reesor Creek Tributary, Whitchurch-Stouffville  
Reach RCT2

A knickpoint/woody debris jam was augmented by anthropogenic materials such as plywood (indicated by the arrow).

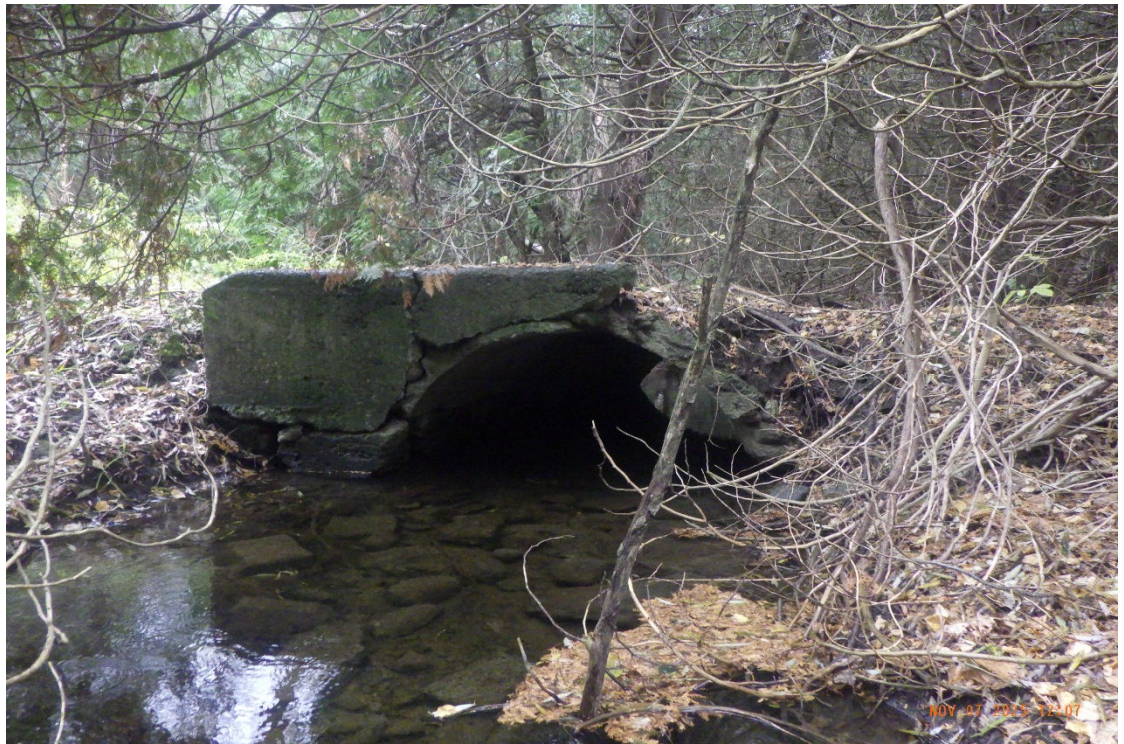
**Photo 6**  
Reesor Creek Tributary, Whitchurch-Stouffville  
Reach RCT2

Photograph taken at the upstream extent of **Reach RCT2** of a culvert crossing in disrepair. Debris from the crossing and large cobbles were present downstream.

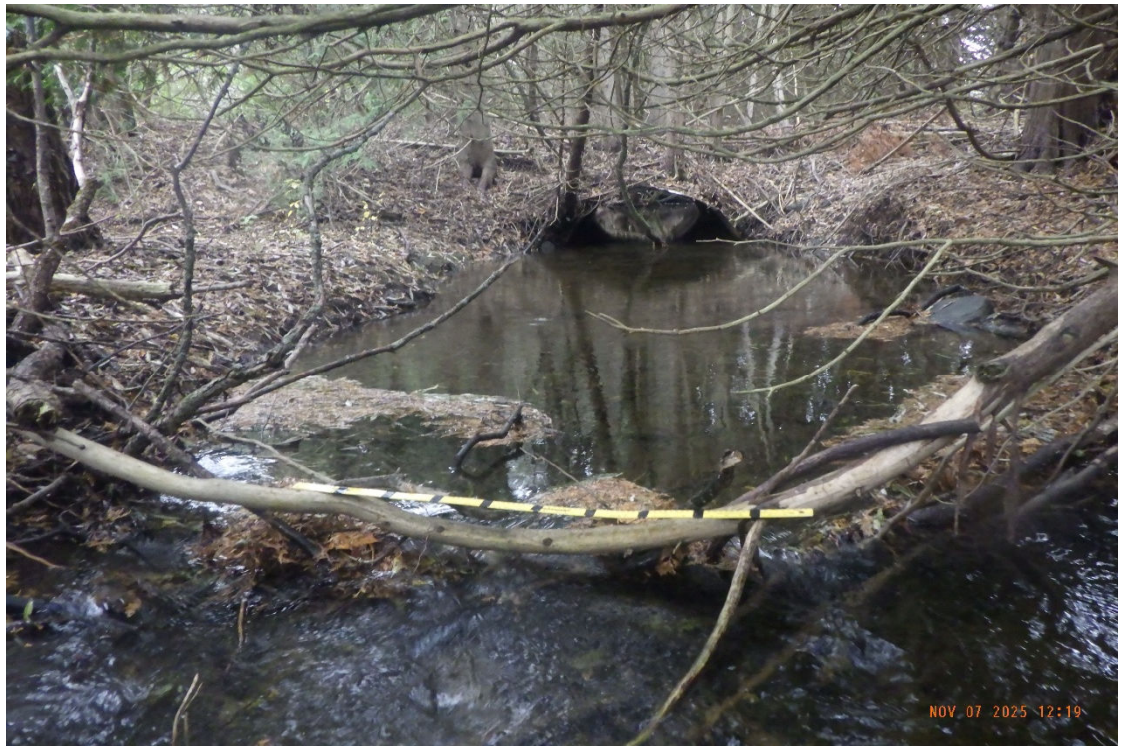
**Photo 7**

Photograph taken facing upstream along the section of reach within 12811 Tenth Line. Some woody debris was present in-stream, and basal scour was minimal through the upstream extent of the reach.

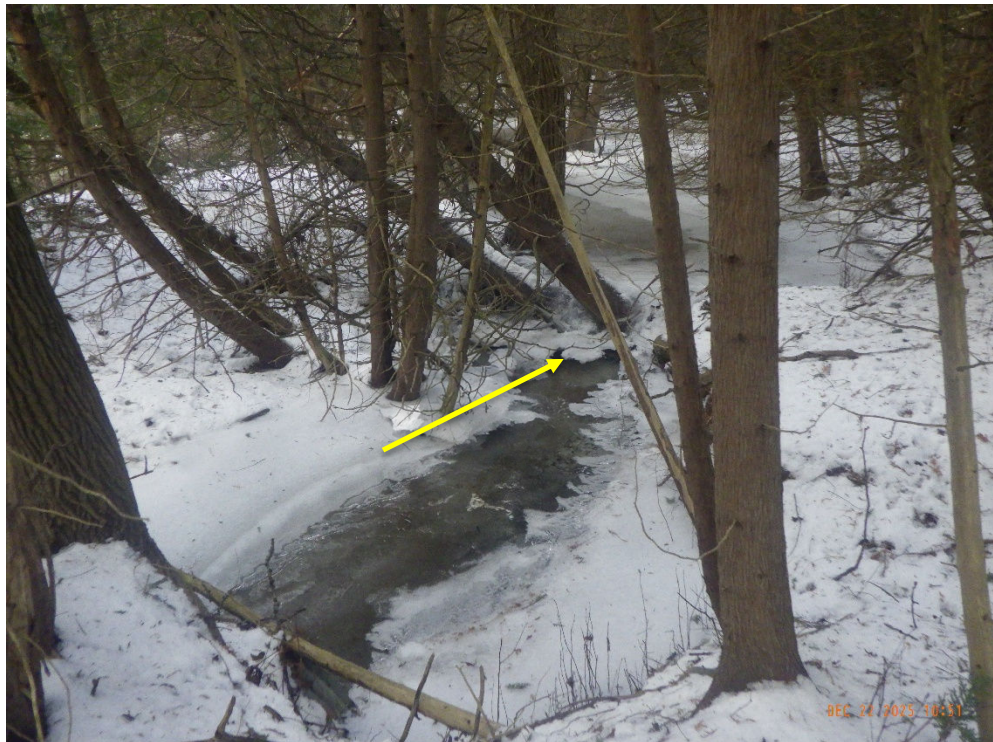
**Photo 8**

Photo of **Reach RCT3** facing upstream. The reach was frozen at the time of assessment. A minor woody debris jam/knickpoint is denoted by the arrow. Note the leaning trees.

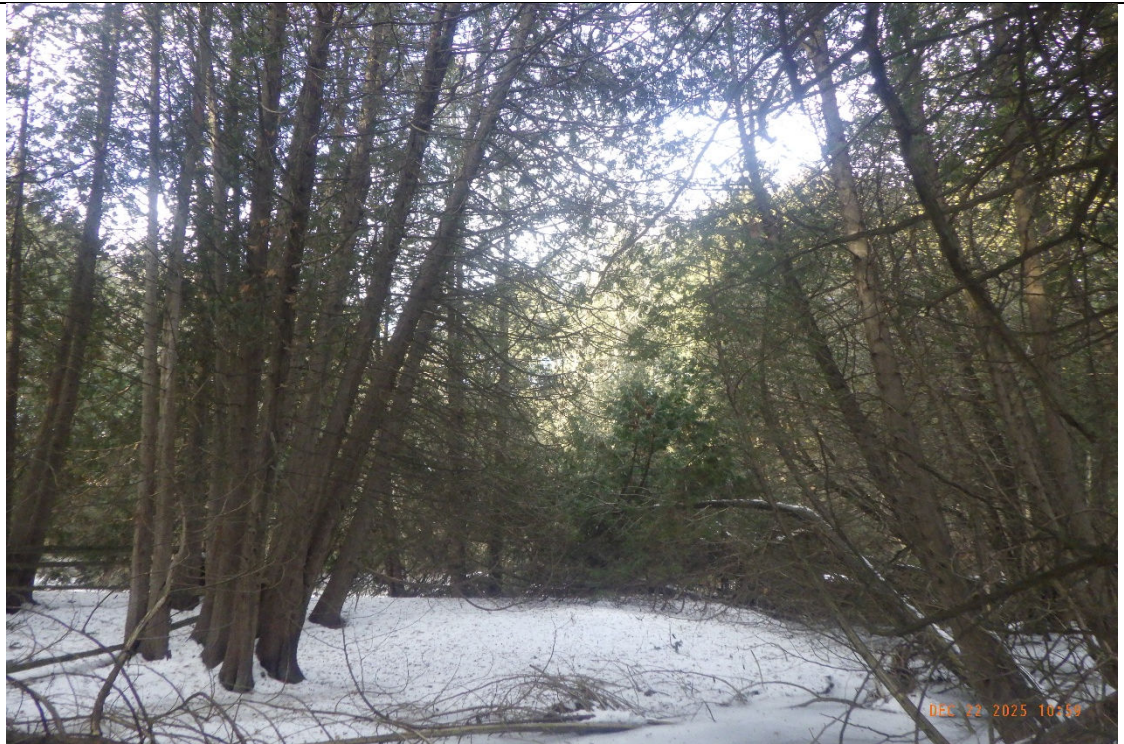
Photo 9

The riparian vegetation along **Reach RCT3** was mostly comprised of trees. Woody debris density was moderate, and leaning trees were common.

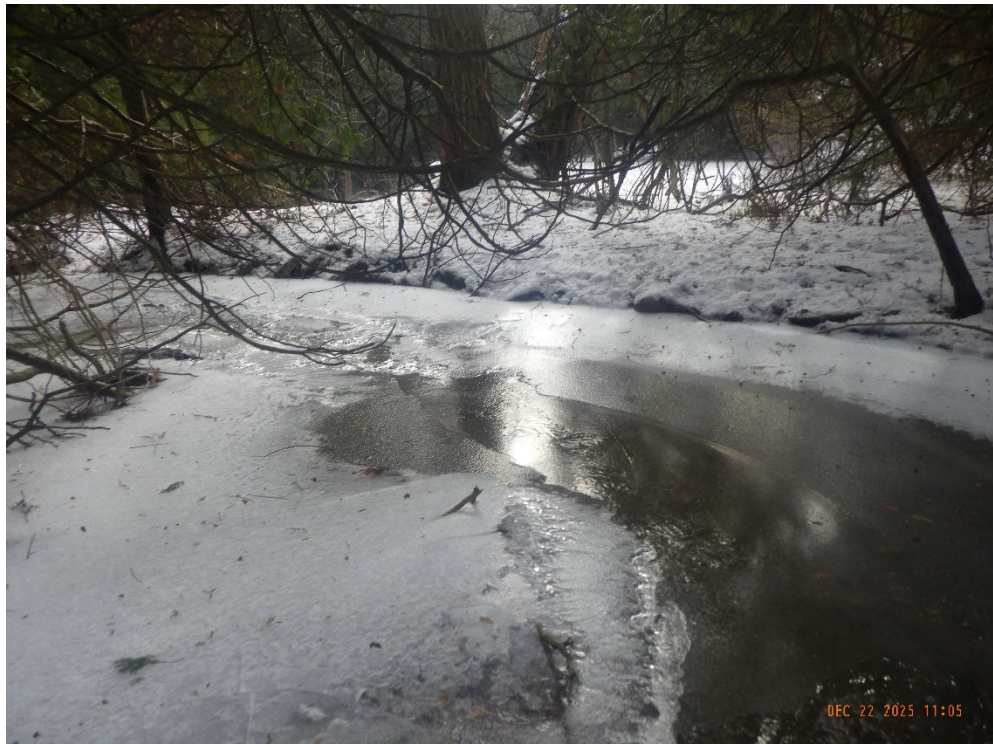
Photo 10

**Reach RCT3** had low sinuosity and irregular meanders. Basal scour (indicated by the steep banks on the outside of the meander) was visible in 30-60% of the reach.

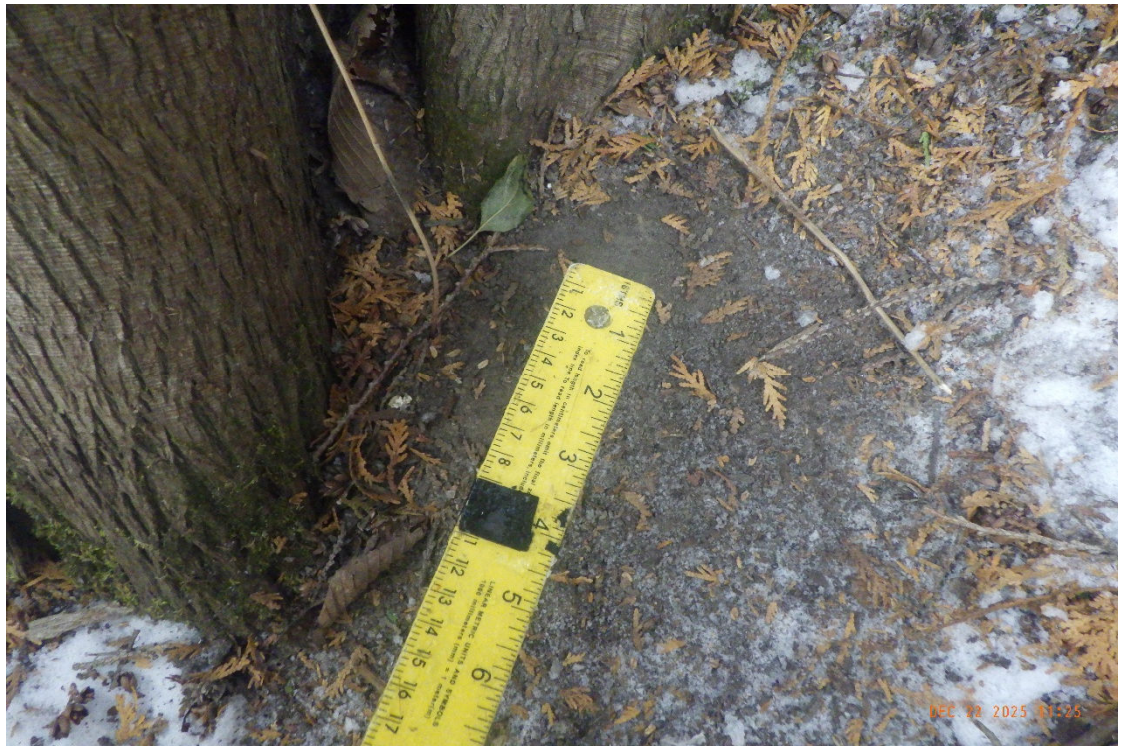
Photo 11

**Reach RCT3** was partially confined along the right bank. The slope substrate was primarily composed of clay and silt with minor sand.

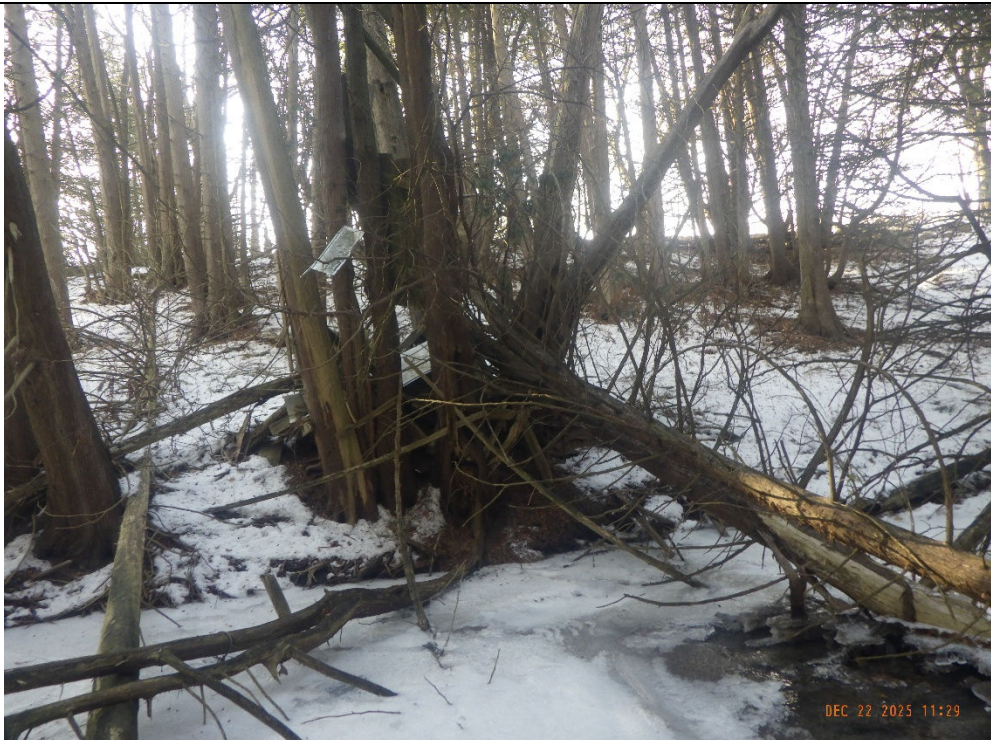
Photo 12

Photograph of valley wall contact along the right bank of the stream. The slope was gentle and heavily treed.
