# TREE INVENTORY AND ASSESSMENT REPORT

## FARSIGHT HOMES - LAKESHORE ROAD

### BALLANTRAE, ON

# Tree Inventory and Assessment Report

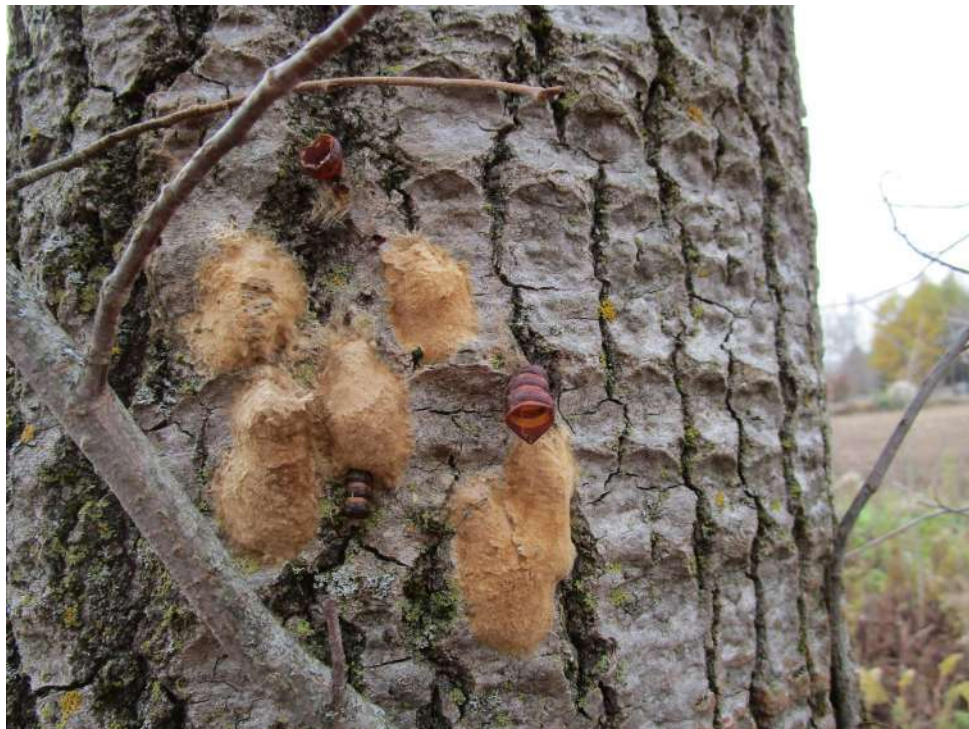
It was noted that many of the trees that are located within the Study Area are affected by the presence of Gypsy Moth (*Lymantria dispar dispar*). Gypsy Moth is an invasive species in Ontario, native to Europe and Asia. It is a forest defoliating insect that feed on the leaves of various tree species. Gypsy Moth eggs & old cocoons were evident on 11.11% (44 total) of trees that were inventoried, most of which were Trembling Aspen *Populus tremuloides*, Black Cherry *Prunus serotina* and Paper Birch *Betula papyrifera*. Refer to the Tree Inventory & Assessment Matrix, Appendix “A” for all individually assessed trees that were affected by Gypsy Moth.

**FIGURE 2 – Gypsy Moth (*Lymantria dispar dispar*) Egg Masses & Cocoons on Poplar Tree**

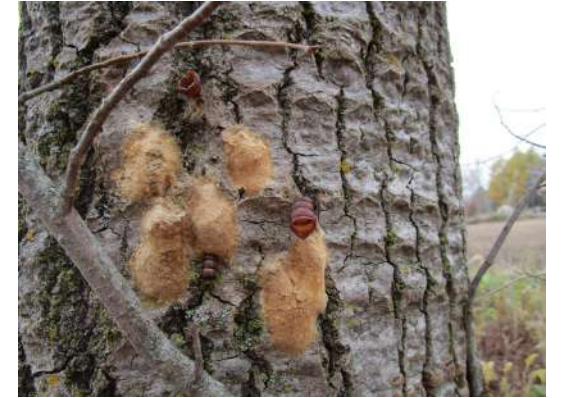
Tree 116 - gypsy moth eggs & cocoons

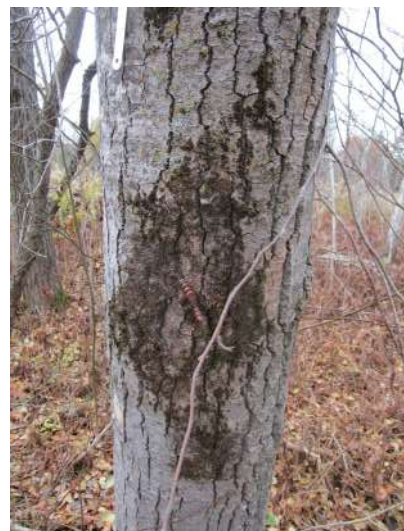
Tree 142 - gypsy moth cocoons
