# TREE INVENTORY AND ASSESSMENT REPORT

## FARSIGHT HOMES - LAKESHORE ROAD

### BALLANTRAE, ON

# Tree Inventory and Assessment Report

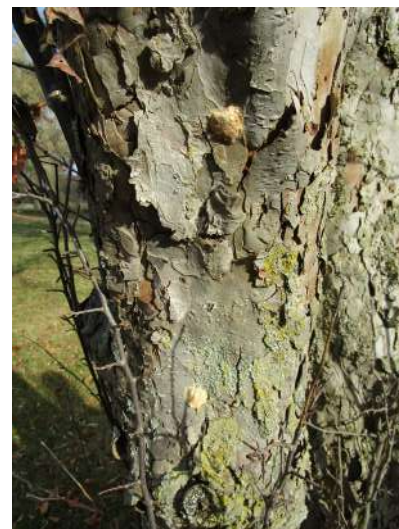
Tree 11 - gypsy moth eggs

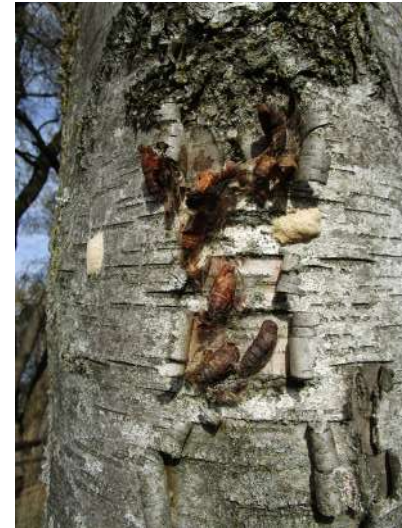
Tree 16 - gypsy moth eggs & cocoons

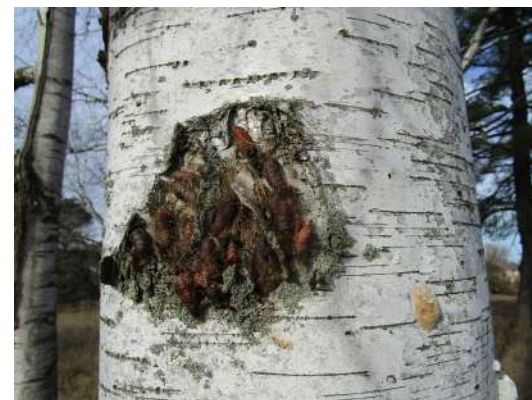
Tree 20 - gypsy moth eggs & cocoons

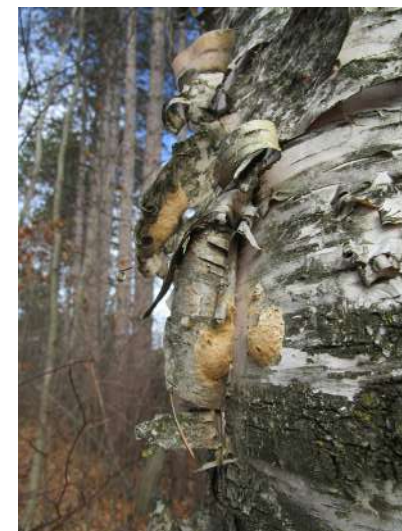
Tree 266 - gypsy moth eggs
